Critical Aquifer Recharge Area Evaluation

REDMOND CENTRAL (PORCH AND PARK)

Redmond, Washington

Project No. 20180378H001

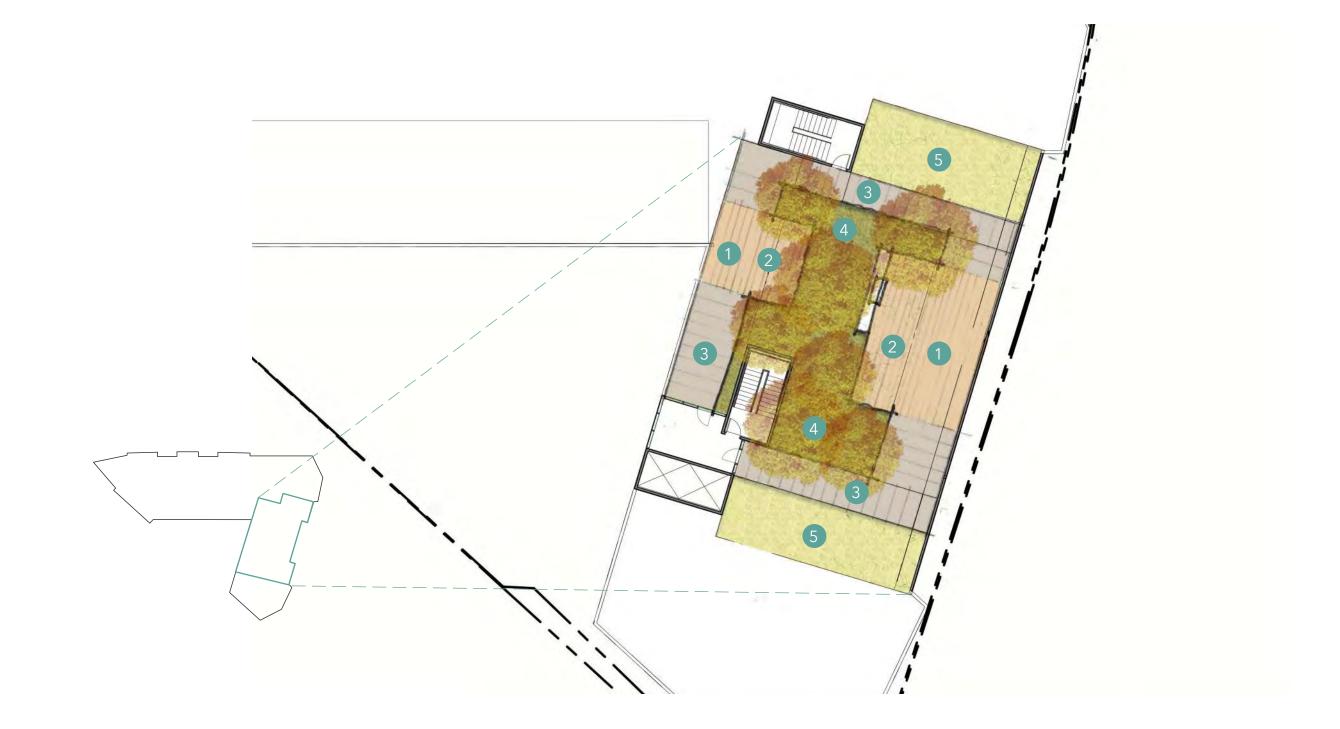
Landscape: Level 03 Courtyard Plan

- 1 Decking
- 2 Gathering Space
- 3 Access Walkway
- 4 Raised Planters
- 5 Greenroof

- Outdoor Amenity
- 2,623 SqFt of Planting

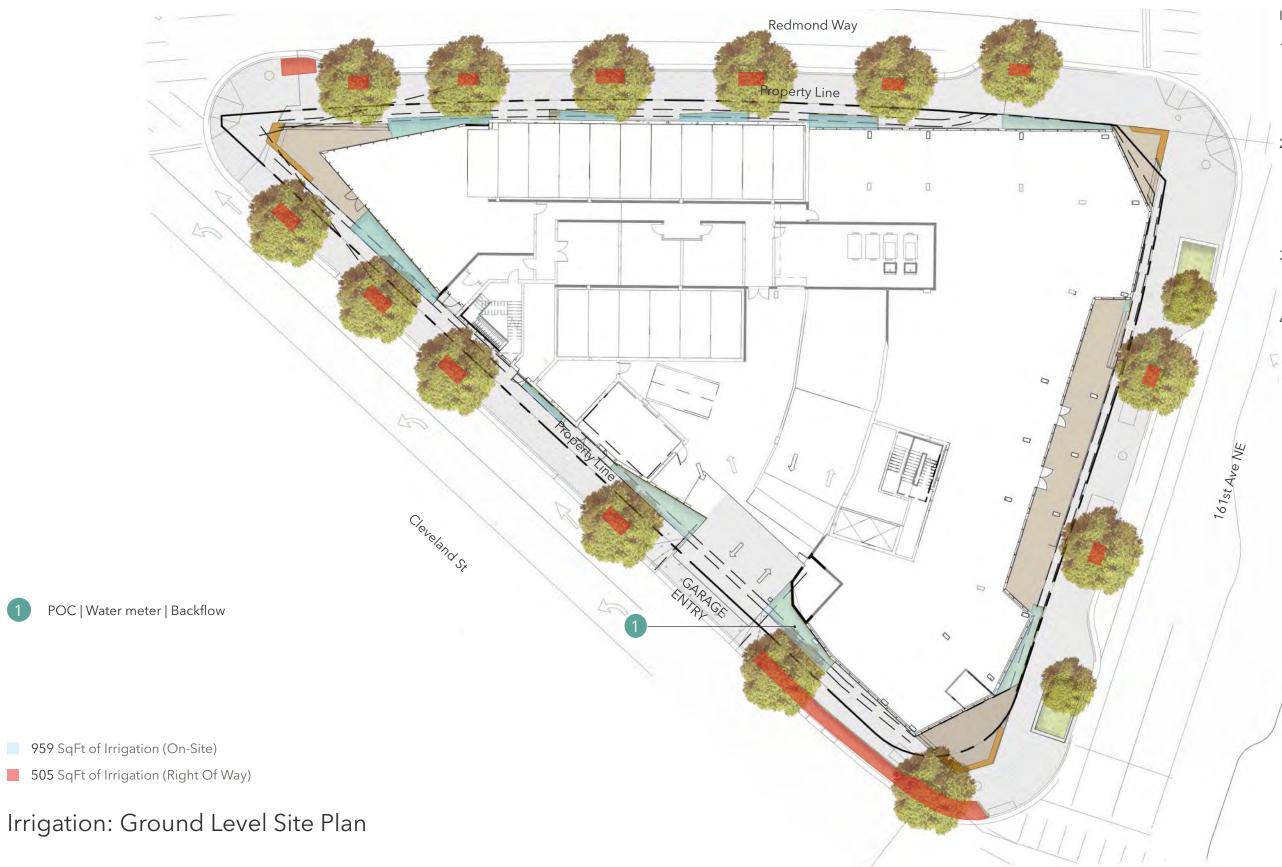
IRRIGATION NOTES

- 1. All proposed planting areas shall be watered with an efficient, complete in-ground automatic irrigation system using sprinkler heads with head-tohead coverage.
- Provide and install all irrigation in conformance with local code standards and appropriate safety regulations. In the event of conflict between these notes and local codes, the codes shall take precedence.
- 3. The irrigation system to be designed shall be based on minimum operating pressure and maximum flow.
- 4. System components to include:
 - POC assembly
 - Flow sensor
 - Master valve
 - Reduced pressure backflow preventer
 - Rainbird controller
 - Quick couplers
 - Weather sensors
 - SCH. 40 mainline

- CL. 200 lateral piping Rainbird spray nozzles and/ or Hunter MPR nozzles.

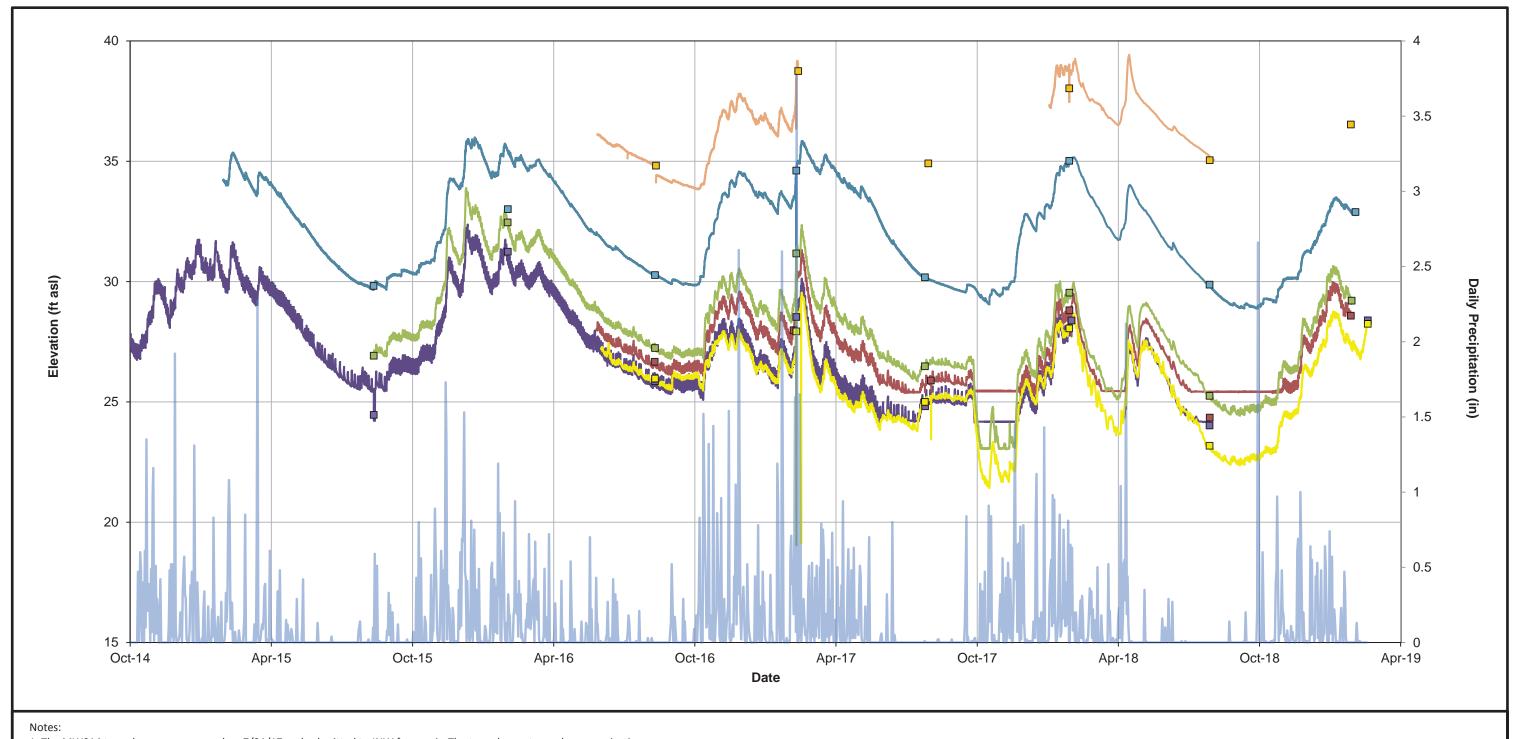
FIGURE **2A**

- 1. The MW014 transducer was removed on 7/31/17 and submitted to INW for repair. The transducer stopped communicating.
- 2. Water levels in MW009 and MW013 dropped below transducers from Late September through Late November 2017.
- 3. Water levels in MW013 dropped below the transducer beginning in early July 2018 and reamined below the transducer through the Summer 2018 sampling event (late July and early August 2018).

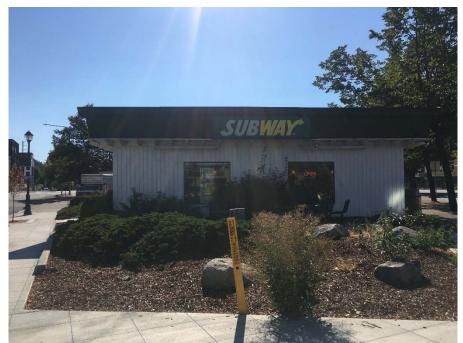
1. FACING EAST-SOUTHEAST FROM THE INTERSECTION OF 160TH AVENUE NORTHEAST AND REDMOND WAY, LOOKING AT THE SUBWAY LOCATED ON PARCEL 1. PERIMETER LANDSCAPING AND SIDEWALKS SUROUND THE SUBWAY.

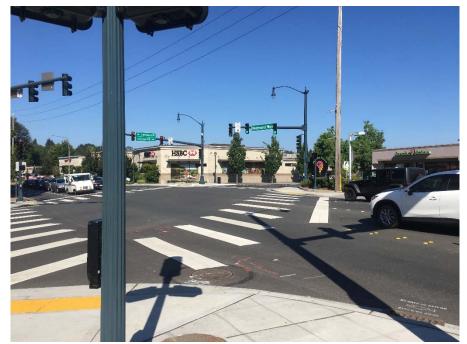
3. FACING NORTHWEST AT THE INTERSECTION OF 160TH AVENUE NORTHEAST AND REDMOND WAY FROM THE WEST BOUNDARY OF THE SUBJECT PROPERTY.

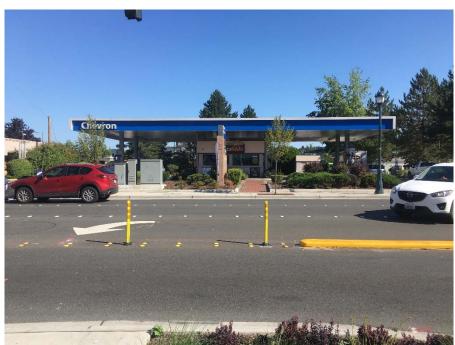
4. FACING NORTH AT THE NORTH-ADJOINING PROPERTY OCCUPIED BY A CHEVRON GAS STATION.

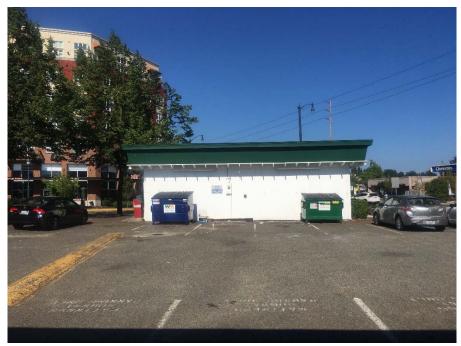
5. FACING WEST-NORTHWEST FROM PARCEL 2, LOOKING AT THE BACKSIDE OF THE SUBWAY RESTAURANT.

GARBAGE AND RECYCLING BINS WERE OBSERVED HERE. MINOR CRACKS AND STAINING WERE OBSERVED ON THE ASPHALT.

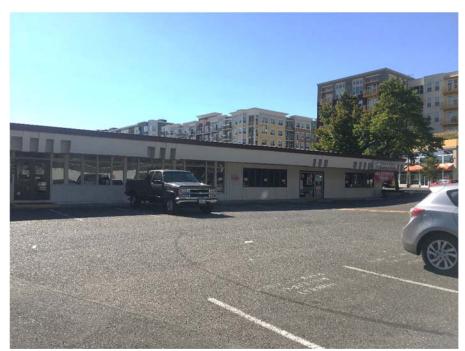
6. FACING SOUTHEAST AT THE FRONT OF THE 6 DAY MATTRESS STORE ON PARCEL 2 (CLOSED AT THE TIME OF SITE VISIT).

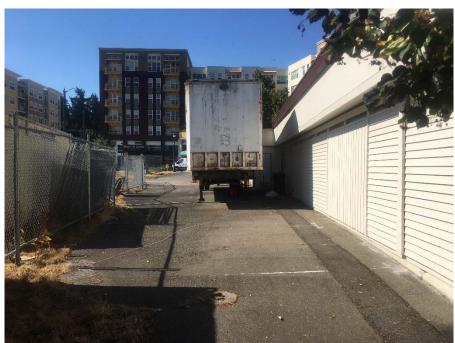
8. FACING SOUTH-SOUTHWEST FROM THE NORTHEAST CORNER OF THE 6 DAY MATTRESS STORE. A TRAILER TO A SEMI-TRUCK WAS OBSERVED BEHIND THE BUILDING. SOME ASPHALT PATCHES WERE OBSERVED HERE AND APPEARED TO BE UTILITIY TRENCHES.

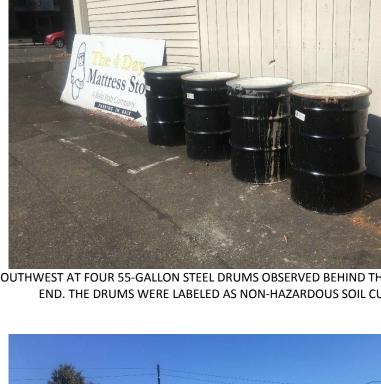
9. FACING SOUTHWEST AT FOUR 55-GALLON STEEL DRUMS OBSERVED BEHIND THE BUILDING ON THE SOUTH END. THE DRUMS WERE LABELED AS NON-HAZARDOUS SOIL CUTTINGS.

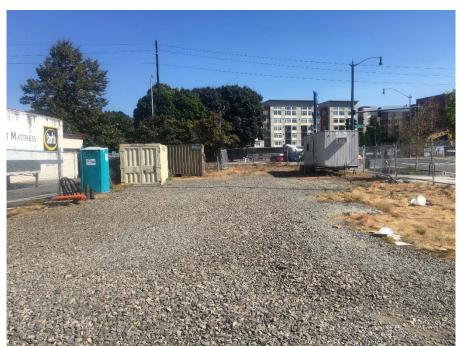
10. FACING NORTH-NORTHEAST, LOOKING AT THE WEST PORTION OF PARCEL 3. MAJORITY OF THE GROUND WAS OVERLAIN WITH GRAVEL. SEVERAL PORTABLE CONTAINERS AND A PORTABLE TRAILER WERE OBSERVED HERE. CHAIN-LINK FENCE SURROUNDED THIS AREA.

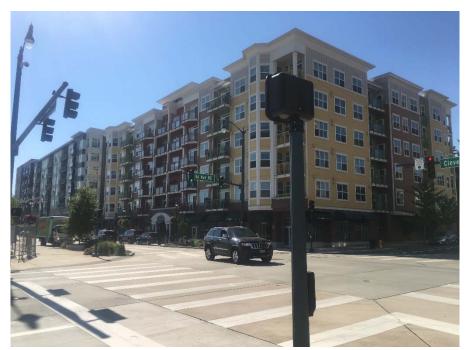
11. FACING SOUTHEAST FROM THE NORTHWEST CORNER OF THE INTERSECTION OF CLEVELAND STREET AND 161ST AVENUE NORTHEAST AT THE SOUTH ADJOINING PROPERTIES OCCUPIED BY A MIXED USE MULTI-FAMILY RESIDENTIAL BUILDING.
